SITE GPR	YEAR 2011	AREA C	SECTOR	ELEVATION Min: 61.397 Max: 61.538	STRATIGRAPHICAL UNIT 2227 <input checked="" type="checkbox"/> Natural <input type="checkbox"/> Anthropic

Gabii Project
--------------------	---------------------	------------------	---------------	--	---	---

DEFINITION All of the robbed-out wall N of room in SW corner (Room 5)

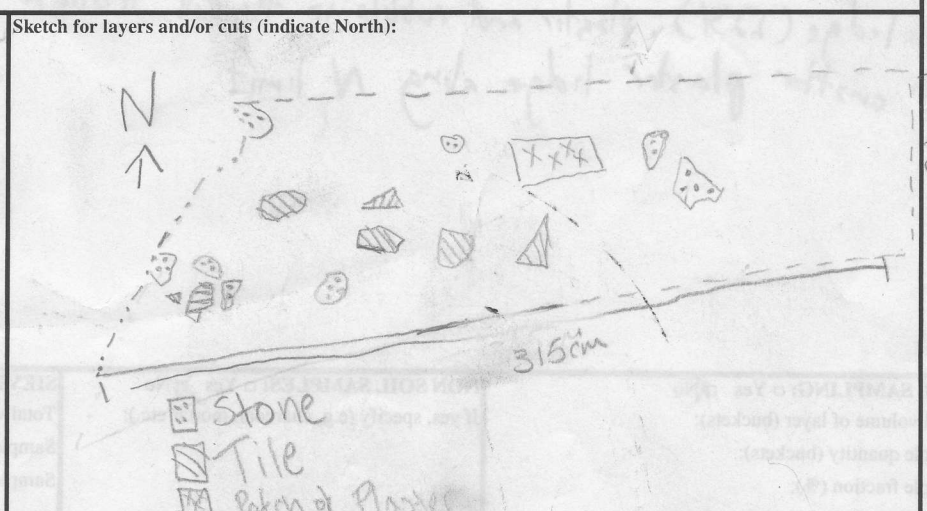
Surface (slope direction; visible inclusions): rubble visible. Edge of plaster wall visible

Observations about inclusions (Clusters? Deposition slope): Significant rubble (stones + tile) throughout SU; plaster mixed in during disturbance of ledge (2231)

disturbance/robbing activity N of room 5, likely removed wall along plaster ledge (2231). Plaster and rubble in the fill indicate presence of wall and possibly another plaster ledge along N limit
