SITE GPR	YEAR 2011	AREA C	SECTOR	ELEVATION Min: <i>not shot in</i> Max:	STRATIGRAPHICAL UNIT 2341 <input type="checkbox"/> Natural <input checked="" type="checkbox"/> Anthropropic

DEFINITION  
Mortar lining of cistern (2339)

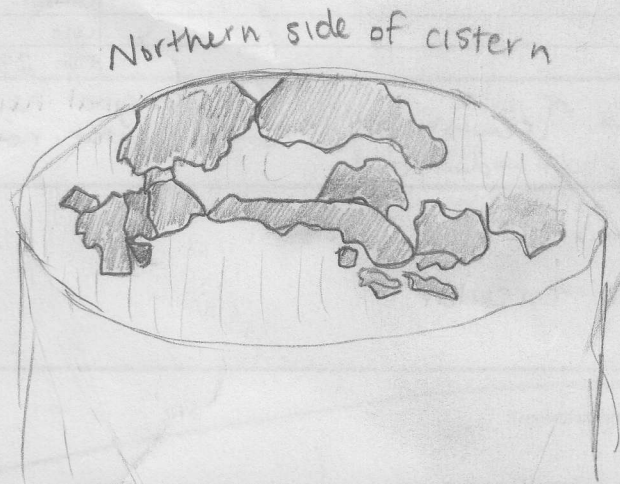
Sketch (if applicable, indicate North)

*heavily degraded  
mortar lining of a  
cistern*

- mortar

**INTERPRETATION** SW 2341 is the mortar lining cistern 2339. It was only photographed + photo modeled but is included on the transparency for fill 2338. The mortar was well preserved on the northern side of the cistern but was heavily distorted on the E and W sides, and appeared to have collapsed to the S. pieces of the mortar were found throughout the fill.
