SITE GPR	YEAR 2013	AREA F	SECTOR S	ELEVATION Min: 60.108 Max: 60.4405	STRATIGRAPHICAL UNIT 5493 <input type="checkbox"/> Natural <input checked="" type="checkbox"/> Anthropic

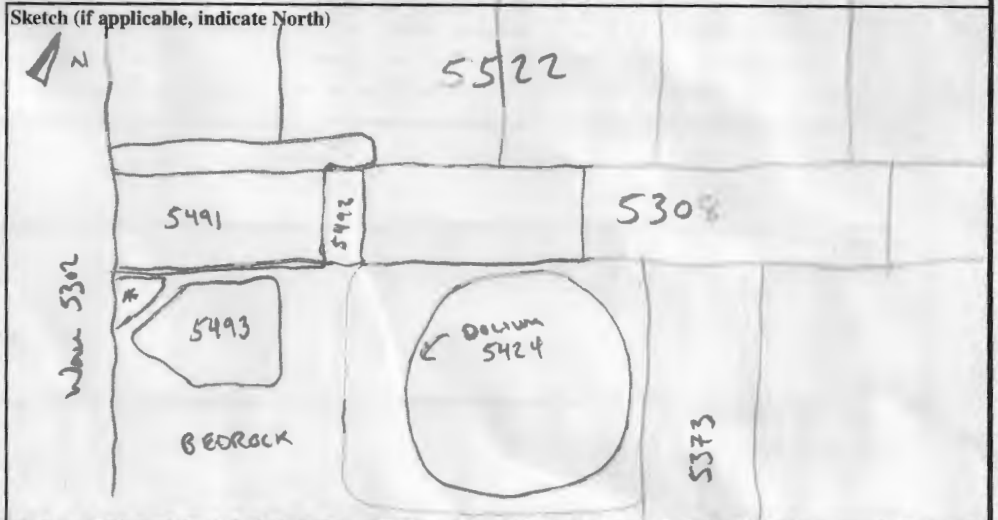
**Sketch (if applicable, indicate North)**

55cm X 55cm X 20cm

SEEMINGLY BROKEN AT NORTHWESTERN AND SOUTHWESTERN CORNERS. AT NW PART OF THE ORIGINAL SLAB MAY BE VISIBLE UNDER THE FOUNDATION OF 5302 (\*) WORKED EDGES AT N, E, AND S.

ALTHOUGH INTERPRETATION IS DIFFICULT GIVEN THE SMALL SIZE, FRAGMENTARY NATURE, AND MARGINAL POSITION OF THIS STONE, BASED UPON ITS THICKNESS AND THE WAY IN WHICH IT IS WORKED, THIS SEEMS TO BE PART OF A BROKEN SLAB, POSSIBLY ORIGINALLY BELONGING TO THE FLOOR OF ROOM 6. IN WHAT HAS BEEN EXCAVATED THUS FAR OF ROOM 6, THE FLOOR HAS OTHERWISE BEEN REMOVED, ALTHOUGH IT MAY BE PRESERVED IN SITU UNDER THE EXCAVATION LIMITS TO THE SOUTH AND WEST. THIS GREAT TUFO SLAB FLOOR WOULD BE ANALOGOUS TO FLOORS 5410 AND 5522/5567.
