SITE GPR	YEAR 2012	AREA D	SECTOR	ELEVATION Min 60.7534 Max 61.1708	STRATIGRAPHICAL UNIT 3163 <input type="checkbox"/> Natural / <input checked="" type="checkbox"/> Anthropogenic

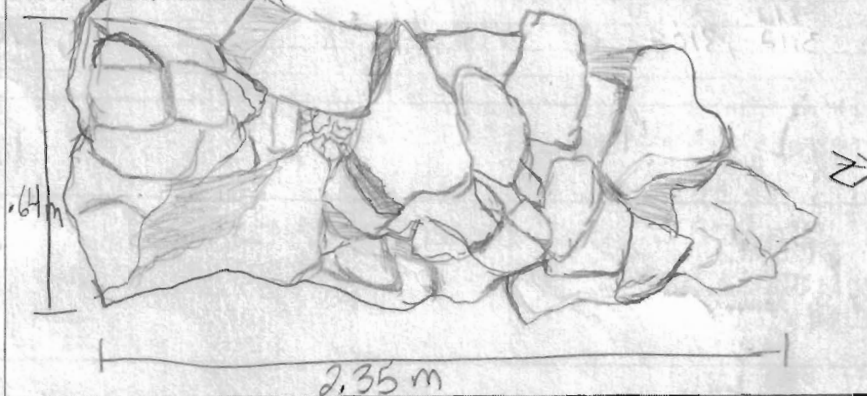
Sketch (if applicable, indicate North)

Alignment: North - South

2.35m x .64m x .33m

linear wall with large irregular shaped blocks.

North-South wall severely truncated; perhaps associated with nearby collapse (3168). It seems that this wall might have been rebuilt from collapse debris; then later robbed along Summit. May be in alignment w/ wall 3067.
