SITE GPR	YEAR 11	AREA B	SECTOR	ELEVATION Min: 62.787 Max: 62.896	STRATIGRAPHICAL UNIT 1450 <input type="checkbox"/> Natural / <input checked="" type="checkbox"/> Anthropic	
-------------	------------	-----------	--------	---	--	--

DEFINITION South Threshold wall of Room N°6	Covered by <input type="checkbox"/> SU: 1327	Fills <input type="checkbox"/> SU:	Filled by <input type="checkbox"/> SU:
--	---	---------------------------------------	---

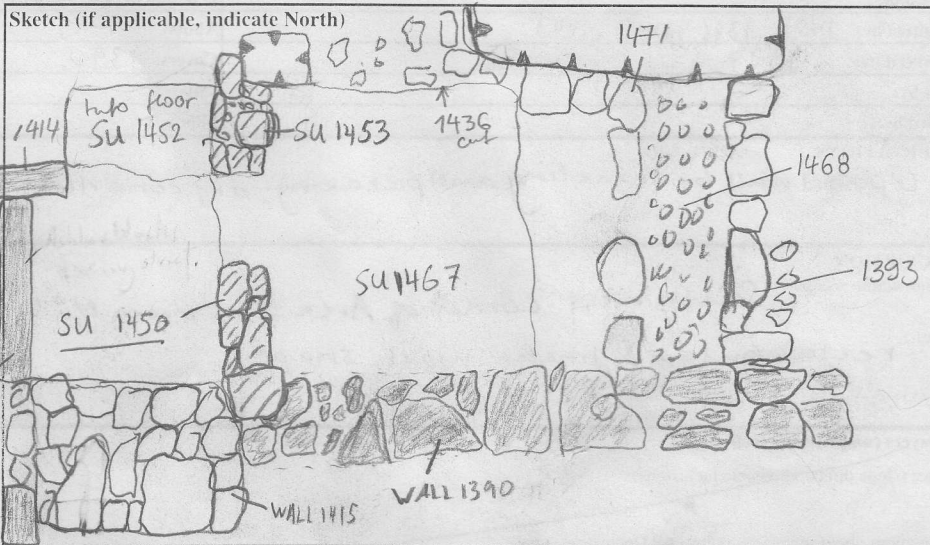
Approx. length, width, height of structural remains: Length ca. 68 cm, width 48 cm, height 50 cm

Description: Small wall of irregular tufo stones, some worked on (only) one side to present a flatter facade. Excavation in the room to west revealed at least 2 "courses" of stones. One stone appears to sit on top of wall 1390 to the south. See photo model 322 for details of individual stones.

SU 1450 is a small wall just to the east of the entrance to the house in area B. It covers wall 1350 + therefore represents one of the more recent phases. It appears to match, in construction technique + rough alignment, wall SU 1453 to the north. The two are separated by a gap of ca. 90cm, which may represent the threshold of the entrance to room 6. However, the orientation of wall 1453 appears slightly off in relation to 1450.
