SITE GPR	YEAR 2012	AREA B	SECTOR	ELEVATION		STRATIGRAPHICAL UNIT 1499 <input type="checkbox"/> Natural <input checked="" type="checkbox"/> Anthropic

Gabii Project
				Min:	Max:		
In cross-section? <input type="checkbox"/> Yes <input checked="" type="checkbox"/> No			In elevation drawing? <input type="checkbox"/> Yes <input checked="" type="checkbox"/> No		Photos: <input checked="" type="checkbox"/> Yes <input type="checkbox"/> No #: 2451-2452		Photo Model: <input type="checkbox"/> Yes <input checked="" type="checkbox"/> No #:
DEFINITION wall like feature				Covered by <input type="checkbox"/> SU:		Fills <input type="checkbox"/> SU:	
HOW IS LAYER DISTINGUISHED? <input type="checkbox"/> Color <input checked="" type="checkbox"/> Composition <input type="checkbox"/> Compaction			FORMATION PROCESS <input type="checkbox"/> Accumulation <input checked="" type="checkbox"/> Construction <input type="checkbox"/> Cutting <input type="checkbox"/> Erosion <input type="checkbox"/> Collapse <input type="checkbox"/> Intentional deposition

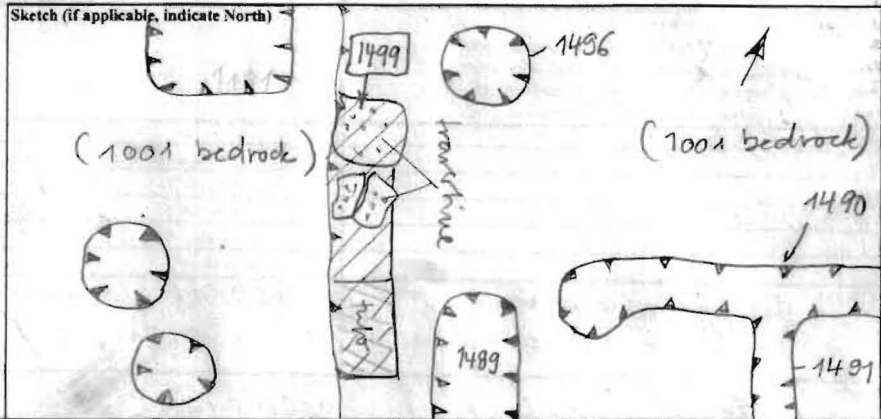
Approx. length, width, height of structural remains: *length: 1m; width: 0,35m; height: 0,08m*

Description: *remains of a built feature from one or two rounded slopes of travertine and a rather square block of local tufo, beneath the stones, there is a little cut in the bedrock*

*remains of a built feature near the cistern (SU 1153). This built feature is situated in the corner behind the drainage channels which feed the cistern SU. Beneath the masonry of feature SU 1499 there is a little cut in the bedrock, probably **

** serving a kind of drainage function for the masonry.*
