SITE GPR	YEAR 2011	AREA C	SECTOR	ELEVATION Min: Max:	STRATIGRAPHICAL UNIT 2231 <input type="checkbox"/> Natural <input checked="" type="checkbox"/> Anthropic

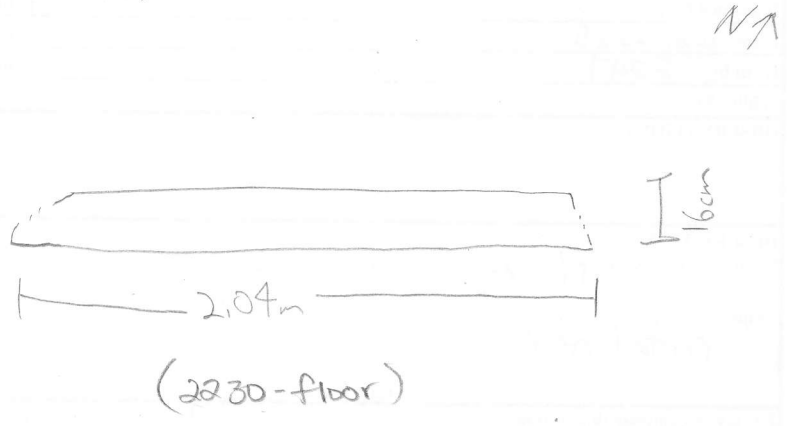
Sketch (if applicable, indicate North)

L=2.04m W=16cm H=0.12m

Description:
Facing was originally smoother but is now partially degraded due to erosion, etc.

Wall was placed on top of floor as a ledge around floor (2230) to mark the perimeter of room 5 as well as lining the walls (ex: 2233) surrounding the room. Cut by later robbing activity (2247) to remove stone wall.
