SITE GPR	YEAR 2011	AREA C	SECTOR	ELEVATION Min: 61.058 Max: 61.467	STRATIGRAPHICAL UNIT 2250 <input type="checkbox"/> Natural <input checked="" type="checkbox"/> Anthropic

DEFINITION N-S wall foundation of large ashlar rufo blocks

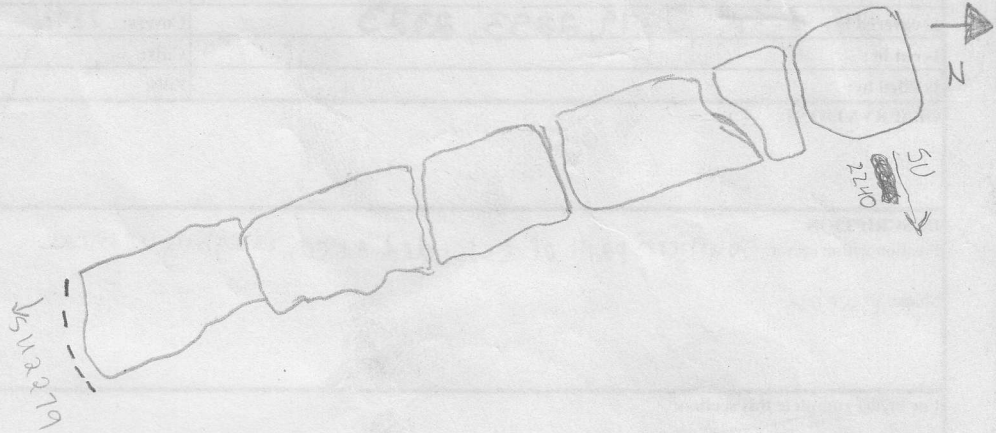
Sketch (if applicable, indicate North)

3.44m 0.46m 0.23m
L W H

Large ashlar tufo blocks with toolmarks visible. The southern two blocks are heavily degraded.

North-south wall likely associated with the 2nd century B.C.E. ^{"house"} It has similar alignment and construction technique with wall further north (2245), possibly on either side of entryway ^(Room C1). The southern limit of the wall remains unclear. SU 2279 did not provide evidence of the continuation of the wall or a robbing cut. However it remains a possibility that 2256 may have connected to other wall (2278). The heavily degraded tufo blocks on the south may be evidence for disturbance or robbing activity. It appears that this wall was later than SU 2240 (which is a wall extending East from the Northernmost Tufo block) because there is a cut ^{store} and rubble in 2240 that could have been caused when 2256 was put in, and the walls to the North ⁽²²⁴⁵⁾ seem similar to 2256 ~~except different tufo~~ while 2240 is a remnant of an earlier basalt construction. No cut was recorded because the walls are being left in, so we couldn't look for it beneath.
