SITE GPR	YEAR 2011	AREA C	SECTOR	ELEVATION Min: 61.3217 Max: 61.4298	STRATIGRAPHICAL UNIT 2275 <input type="checkbox"/> Natural <input type="checkbox"/> Anthropic

DEFINITION Grey tufo blocks N of wall 2260	Covered by <input type="checkbox"/> SU: 0	Fills <input type="checkbox"/> SU:	Filled by <input type="checkbox"/> SU:
---	--	---------------------------------------	---

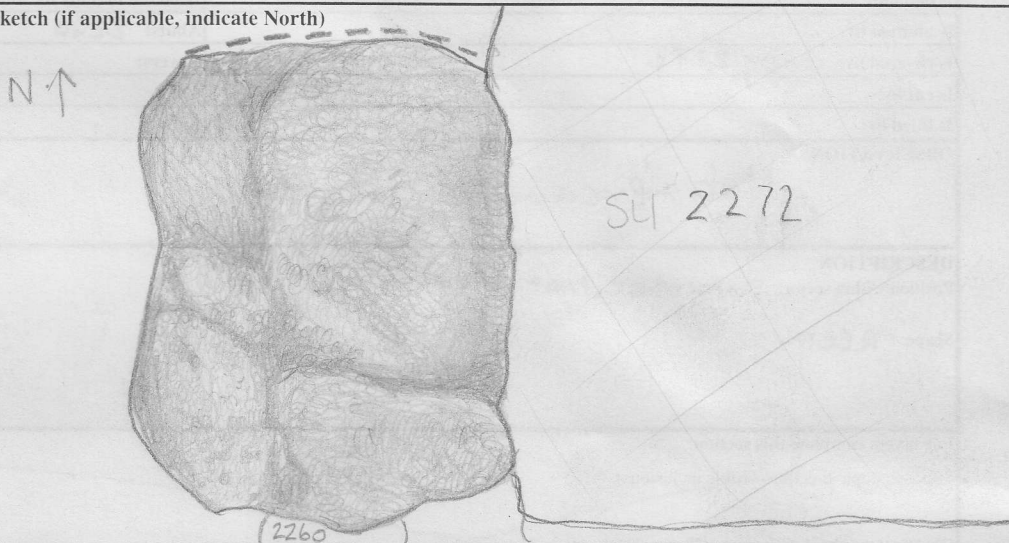
Sketch (if applicable, indicate North)

large tufo block abutted by floor 2272, touching Northern corner of wall 2260. grey color, roughly rectangular some cracking on surface, mostly flat.

- probably formed the southern limit of a now robbed N-S wall
- formed corner - abutted by floor on east side and southern limit is equal to the floor's
- difference in construction material to basalt wall 2260 suggests they are of different phases but the fact that they are both abutted by floor 2272 suggests they may be contemporaneous.
- roughly same alignment as wall 2179 to the north, which forms the boundary BETWEEN ROOMS C2 AND C3, AND AS THE ROBBING ACTIVITY THAT REMOVED THE EASTERN WALL OF ROOM C5, WHICH SUGGESTS THAT THIS WALL BELONGS TO THE SAME CONSTRUCTION PHASE.
