SITE GPR	YEAR 2011	AREA C	SECTOR	ELEVATION Min: 61.1505 Max: 61.2502	STRATIGRAPHICAL UNIT 2306 <input type="checkbox"/> Natural <input type="checkbox"/> Anthropic

DEFINITION  
E-W wall of irregular basalt stones aligned with 2274

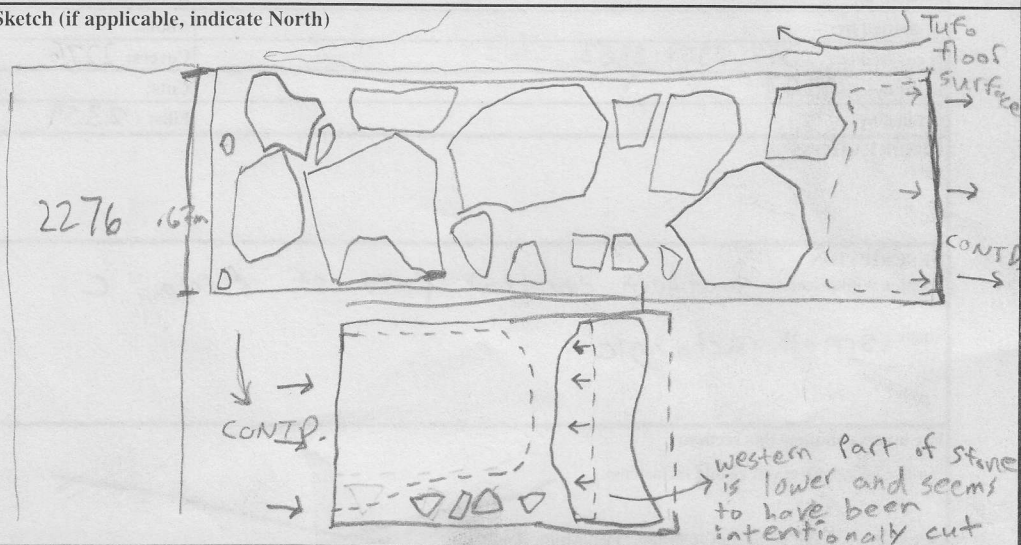
Sketch (if applicable, indicate North)

2.8 m x 0.67 m

The wall joins with 2276 to the West. In the eastern part there is a gap and then one at the Eastern end. This final stone seems to have been intentionally cut on the left side, but truncated by later activity on the right side, where the wall may have originally continued. Tufo floor surface comes up against the Northern side of the wall.

This wall seems to form a part of the southern boundary of the atrium and the northern boundary of one of the rooms coming off the southern side of the atrium. To the east, the gap between the main wall and the Eastern cut rock seems to be a threshold between the room and atrium (like the one in 2274 to the west of 2276). To the east of the SU, it seems like the wall may have originally continued, but was truncated by some later activity.
