SITE GPR	YEAR 2010	AREA A	SECTOR	ELEVATION Min: 64.51 Max: 64.84	STRATIGRAPHICAL UNIT 381 <input type="checkbox"/> Natural <input checked="" type="checkbox"/> Anthropic	
				In cross-section? <input type="checkbox"/> Yes <input type="checkbox"/> No	In elevation drawing? <input type="checkbox"/> Yes <input type="checkbox"/> No

DEFINITION Wall socket N of well 352, through rubble 373	Covered by <input checked="" type="checkbox"/> SU: 385	Fills <input checked="" type="checkbox"/> SU: 386	Filled by <input type="checkbox"/> SU:
---	---	--	---

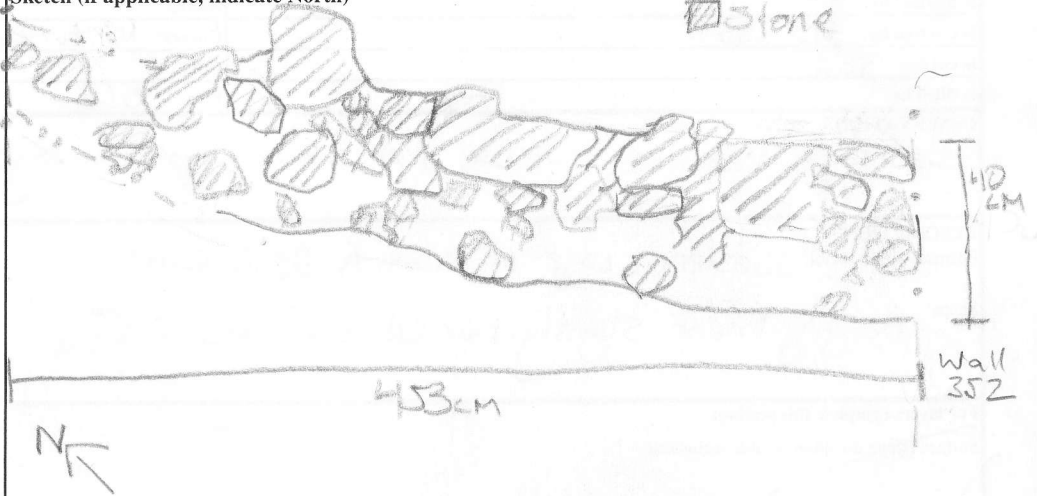
Sketch (if applicable, indicate North)

Dimensions of socle
 4.53m long
 40cm wide
 50cm high
 Grey tufa
 Stones (LxWxH)
 Large: 44x34x12cm
 Medium: 10x27x17cm
 Small: 11x8x5cm

Quarry cut ³⁸⁶ was partially filled with rubble, 381 is socle of wall built on top of rubble and socle is not always distinguishable from rubble. Cut was later backfilled with quarry construction debris.

381 is equal to socle 387 to the S of later wall 352. Socle was cut and partially destroyed at a slope by later cut 382. We presume a wall, the extension of 363 would have originally stood atop the socle and was also destroyed by cut 352.
