SITE GPR	YEAR 2013	AREA F	SECTOR South	ELEVATION Min: 60.2114 Max: 60.11112	STRATIGRAPHICAL UNIT 5319 <input type="checkbox"/> Natural <input checked="" type="checkbox"/> Anthropic

Crack in floor
 in Room 2, areas 5346, 5347,
 Covered in 5318

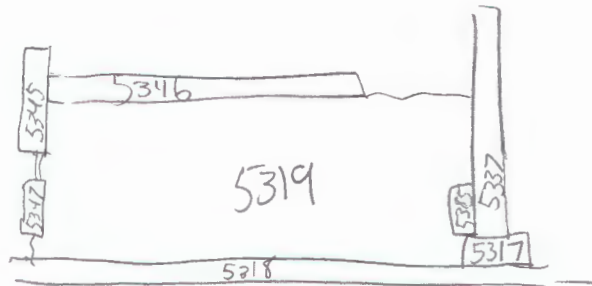
Sketch (if applicable, indicate North)

Preparation for mosaic floor surface similar to that in Room 2. Cut by robbery
 cut that is filled by 5385. Part of the same phase as 5345, 5347, 5346
 5383, 5357, constructed after the walls
