SITE GPR	YEAR 13	AREA F-South	SECTOR	ELEVATION Min: 59.07 Max: 59.11	STRATIGRAPHICAL UNIT 5433 <input type="checkbox"/> Natural <input type="checkbox"/> Anthropic

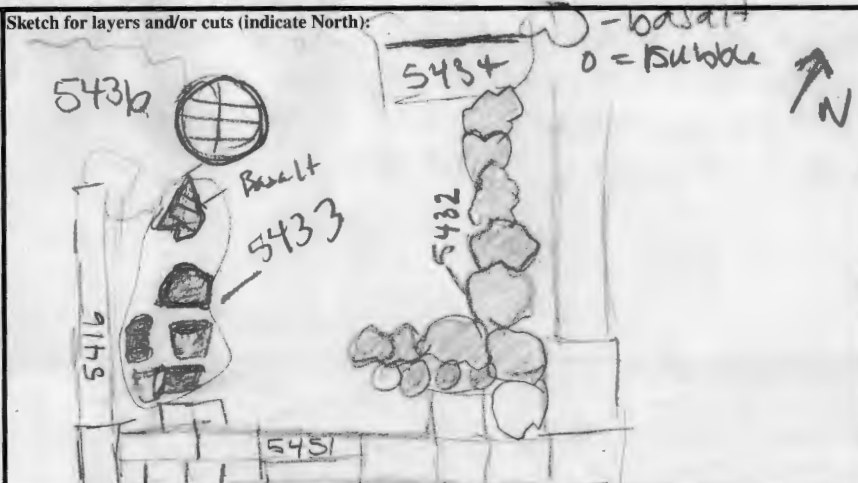
OBSERVATIONS Previously excavated by the Soprintendenza 15 years ago, re-exposed 2013							
DESCRIPTION Position within sector: West of wall 5432 and east of wall 5416 Shape: Irregular, round shaped tufo, basalt paver							
For layers complete this section: Surface (slope direction; visible inclusions): Four tufo column drums, one basalt paver Observations about inclusions (Clusters? Deposition slope) Inclusions cluster to the south Observations about thickness (Increases? Decreases?): — Nature of the interface with layer below: <input checked="" type="checkbox"/> sharp <input type="checkbox"/> diffuse <input type="checkbox"/> commingled <input type="checkbox"/> other (specify)							
For cuts complete this section: Cut edges: <input type="checkbox"/> rounded <input type="checkbox"/> straight Cut sides: <input type="checkbox"/> straight <input type="checkbox"/> concave <input type="checkbox"/> convex <input type="checkbox"/> sloping Cut bottom: <input type="checkbox"/> flat <input type="checkbox"/> concave <input type="checkbox"/> irregular How is cut top edge? <input type="checkbox"/> sharp <input type="checkbox"/> rounded How is cut bottom edge? <input type="checkbox"/> sharp <input type="checkbox"/> rounded Observations:				Sketch for layers and/or cuts (indicate North):

This collapse of ground, worked tufo suggest a collapse of a column and the basalt paver closely resembles the ones on the via prenestina. This collapse might have been caused by the Soprintendenza, who may have placed these stones here during excavation, but it is also possible they collapsed naturally from nearby festives.
