SITE GPR	YEAR 19	AREA F-South	SECTOR	ELEVATION Min: 58.9315 Max: 59.1793	STRATIGRAPHICAL UNIT 5535 <input type="checkbox"/> Natural <input type="checkbox"/> Anthropic

In cross-section? <input type="checkbox"/> Yes <input checked="" type="checkbox"/> No		In elevation drawing? <input type="checkbox"/> Yes <input checked="" type="checkbox"/> No		Photos: <input checked="" type="checkbox"/> Yes <input type="checkbox"/> No #: 3118-19	
DEFINITION Wall of drainage canal			Covered by <input checked="" type="checkbox"/> SU: 0		Fills <input type="checkbox"/> SU:	Filled by <input type="checkbox"/> SU:
HOW IS LAYER DISTINGUISHED? <input type="checkbox"/> Color <input type="checkbox"/> Composition <input type="checkbox"/> Compaction			FORMATION PROCESS <input type="checkbox"/> Accumulation <input checked="" type="checkbox"/> Construction <input type="checkbox"/> Cutting <input type="checkbox"/> Erosion <input type="checkbox"/> Collapse <input type="checkbox"/> Intentional deposition

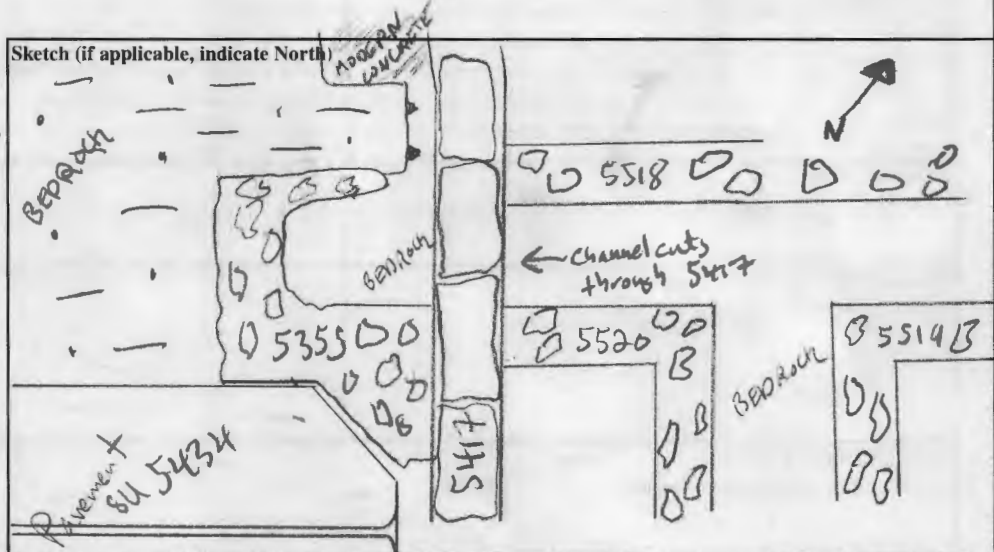
Sketch (if applicable, indicate North)

Description: *Mortared Rubble wall with pieces of tufo, basalt, travertine & tile. Sits directly on bedrock. Feature forms three sides of a channel which then cuts through ashlar wall 5417 to the east. Gap in northern wall where it meets 5417.*

SU 5355 is the wall of a drainage channel formed also by 5518, 5519, 5520 on the other, eastern, side of 5417. The channel cuts through this ashlar wall, which must have been out of use when it was constructed. The gap in the north leads to a square cut in the bedrock, now filled with modern concrete, possibly also associated with water movement. This then joins the cut (SU 5418) for 5417 - if water drained through here, 5417 must certainly have been out of use.
